STATUS OF MOUNT KINABALU WATER CATCHMENTS AFTER THE JUNE 2015 RANAU EARTHQUAKE – LESSONS LEARNED

Felix Tongkul Natural Disaster Research Centre

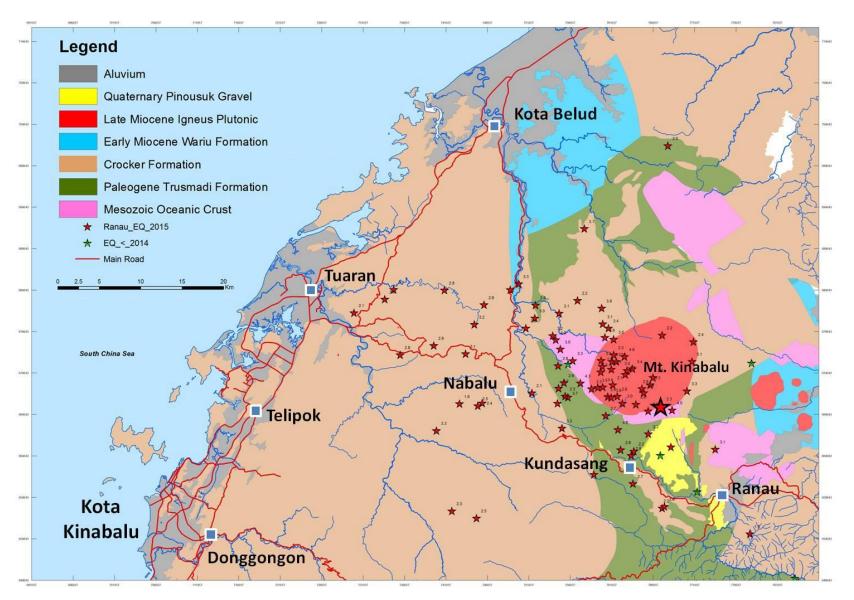
Ranau Mainshock and Aftershocks

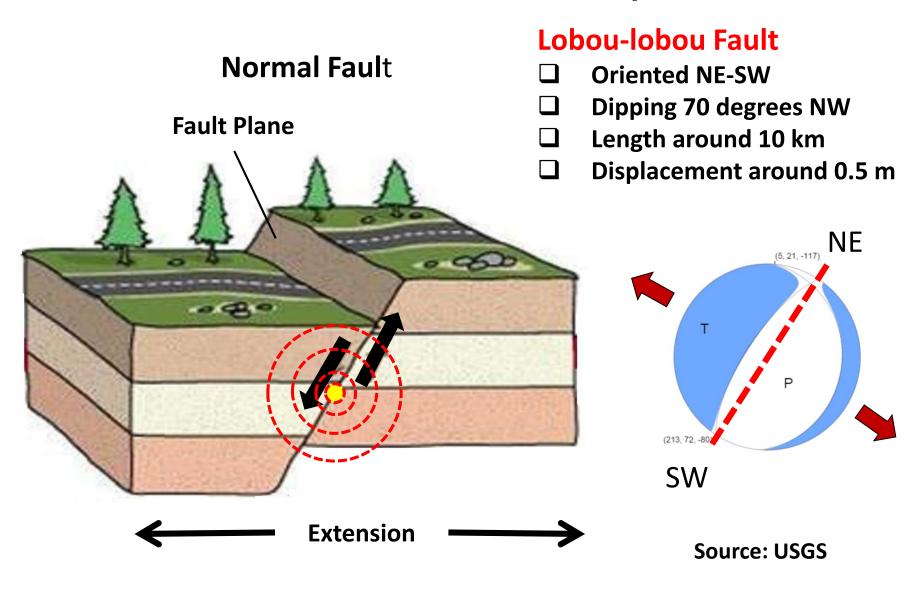
What Caused the Ranau Earthquake?

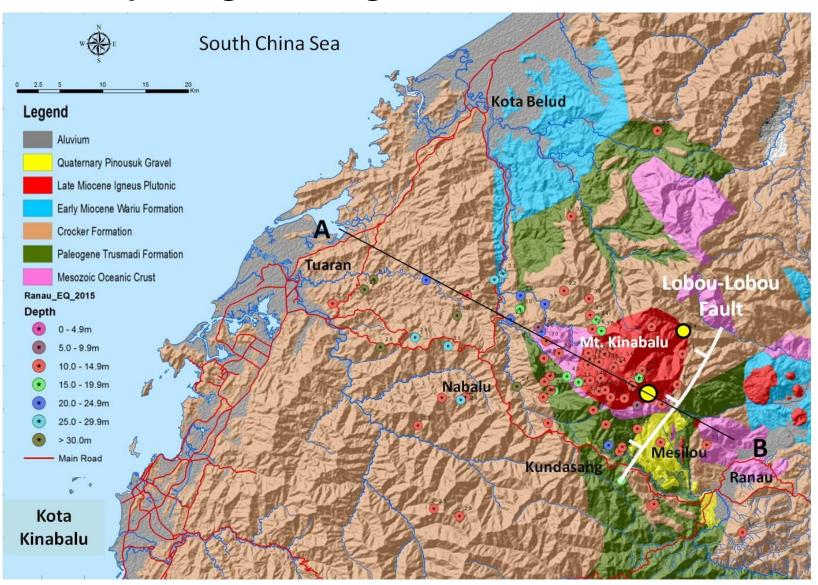
Earthquake-generating Fault - Lobou-Lobou Fault

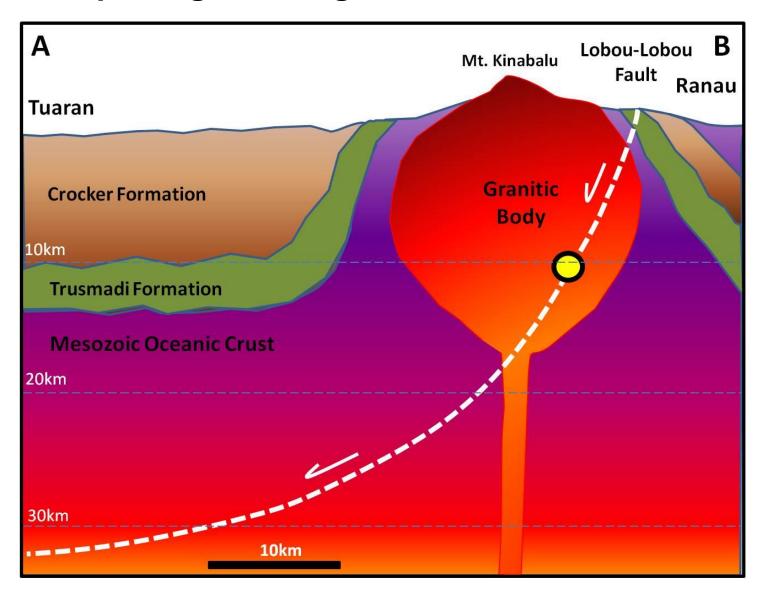
Earthquake-generating Fault - Lobou-Lobou Fault

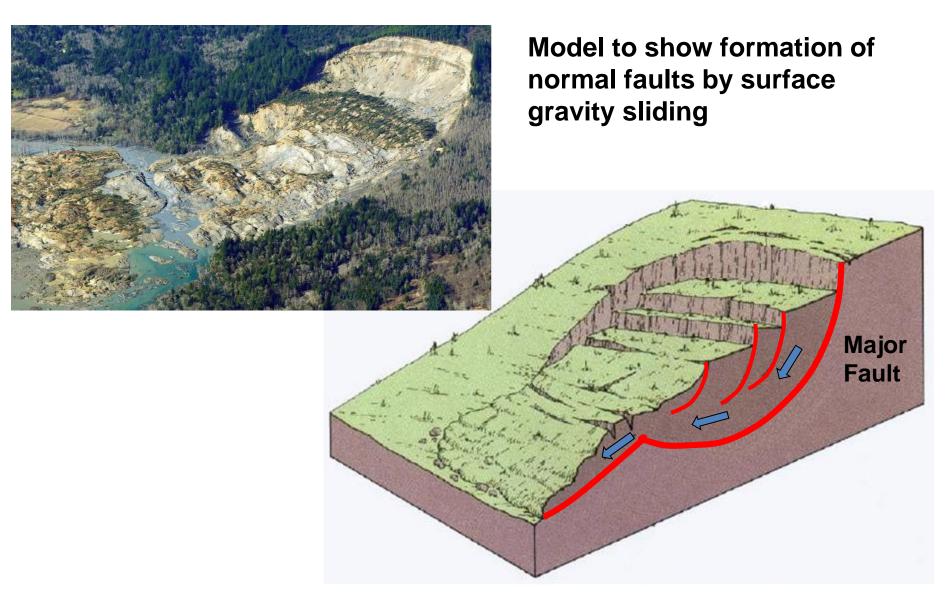
Mechanism for Normal Faulting

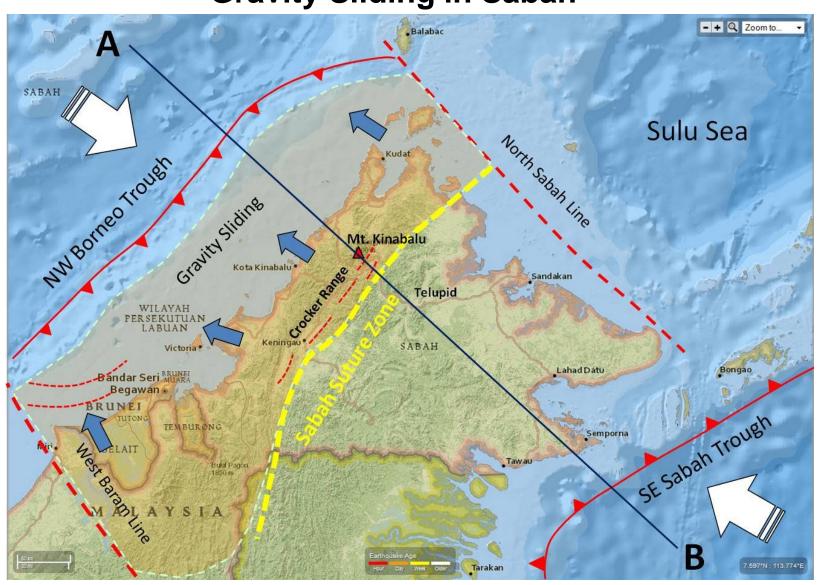
Gravity Sliding in Sabah

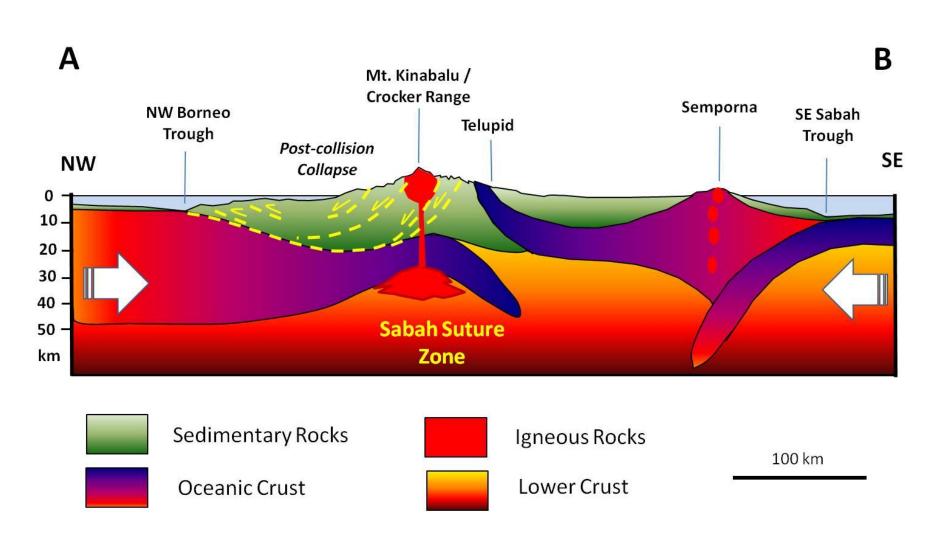
Gravity Sliding in Sabah

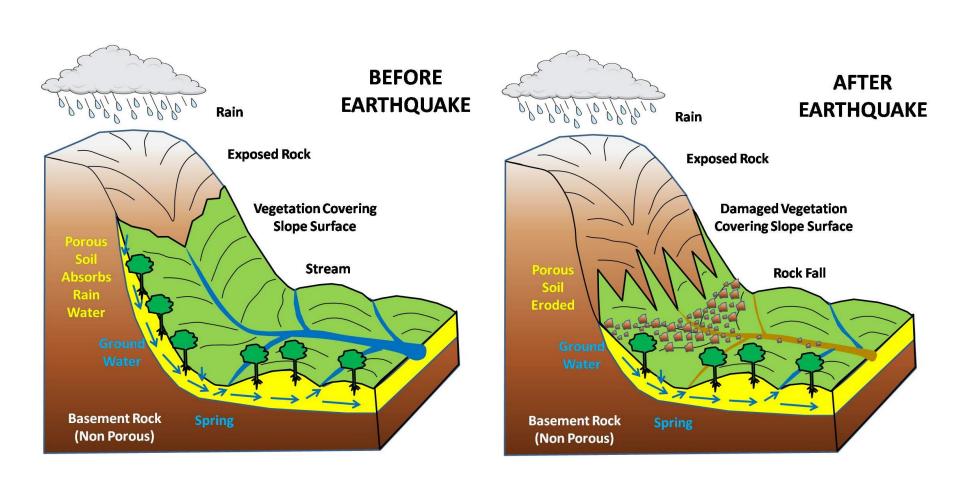
Reduced capacity to absorb and retain rain water

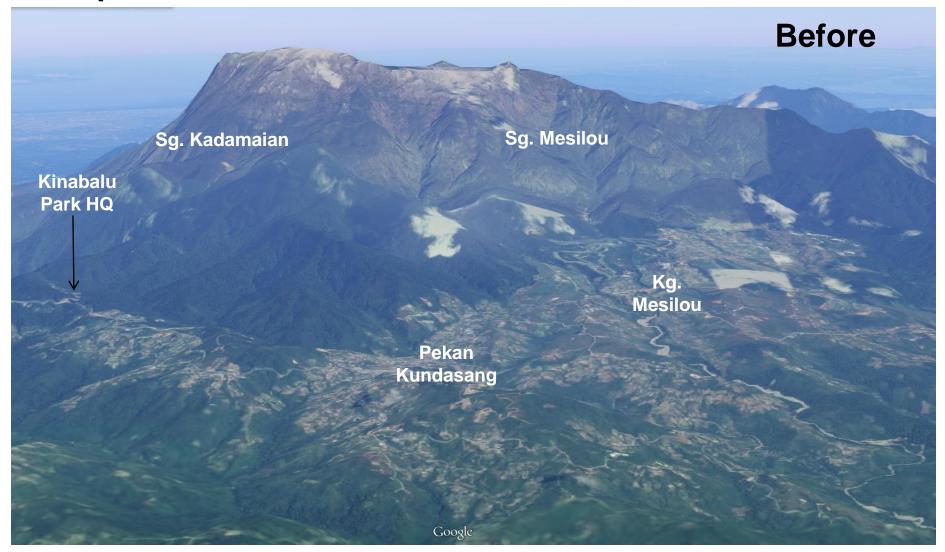
Massive landslide occurred around Mount Kinabalu, except on the northeast side

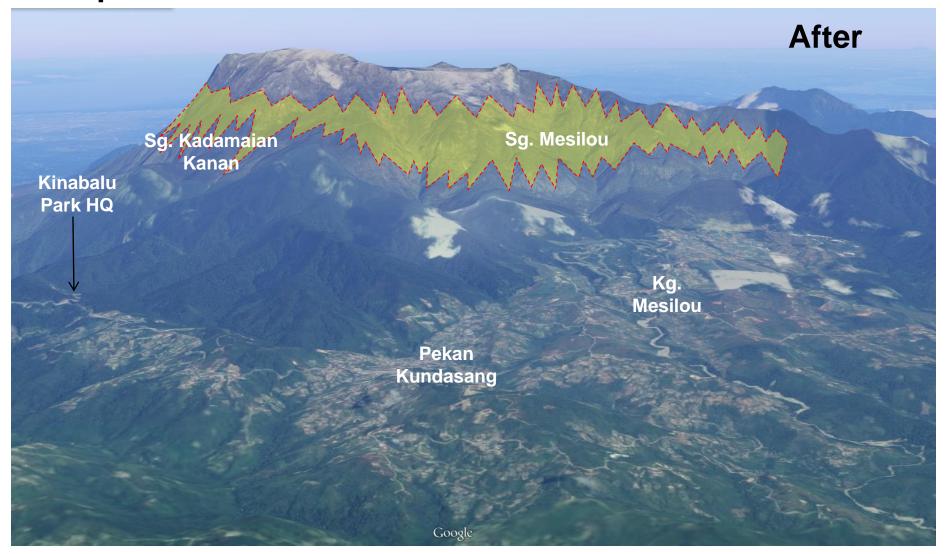
Massive landslide occurred around Mount Kinabalu, except on the northeast side

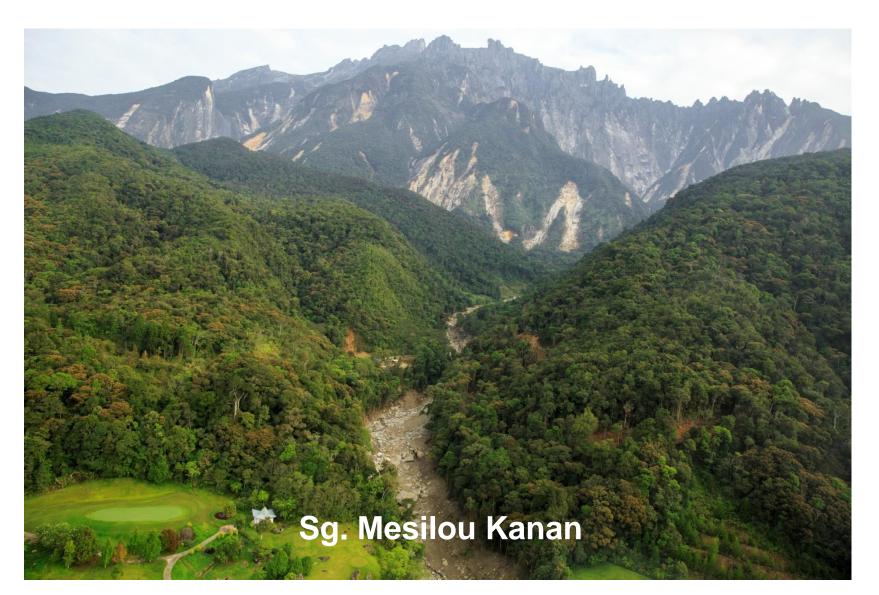
Destruction of water catchments

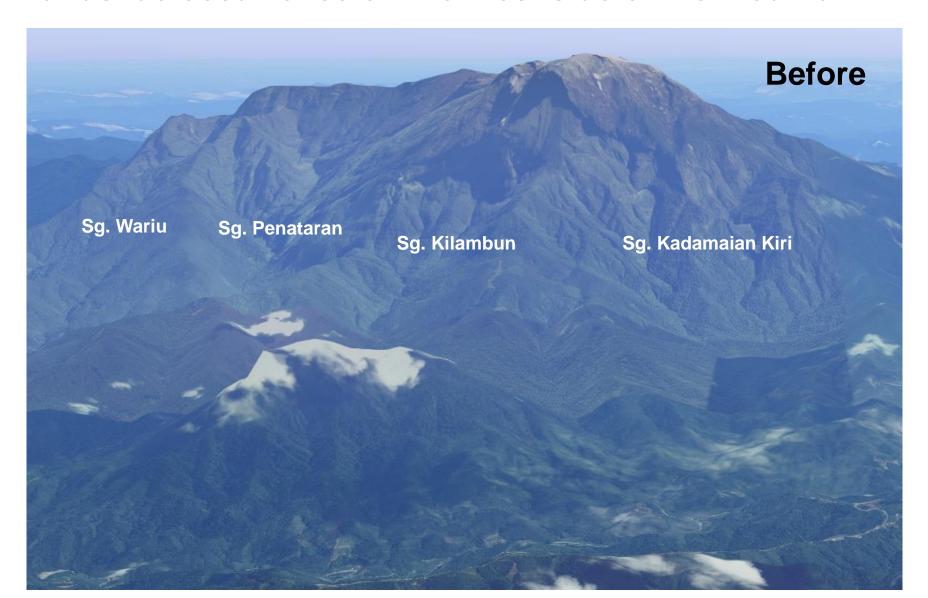
Landslide occurrence on the West side of the mountain.

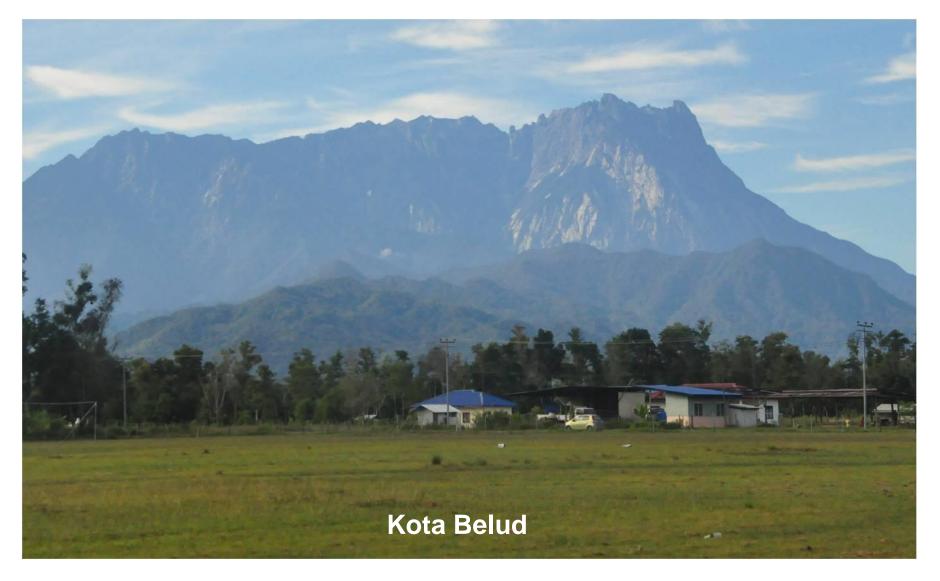
Landslide occurrence on the NW of the mountain.

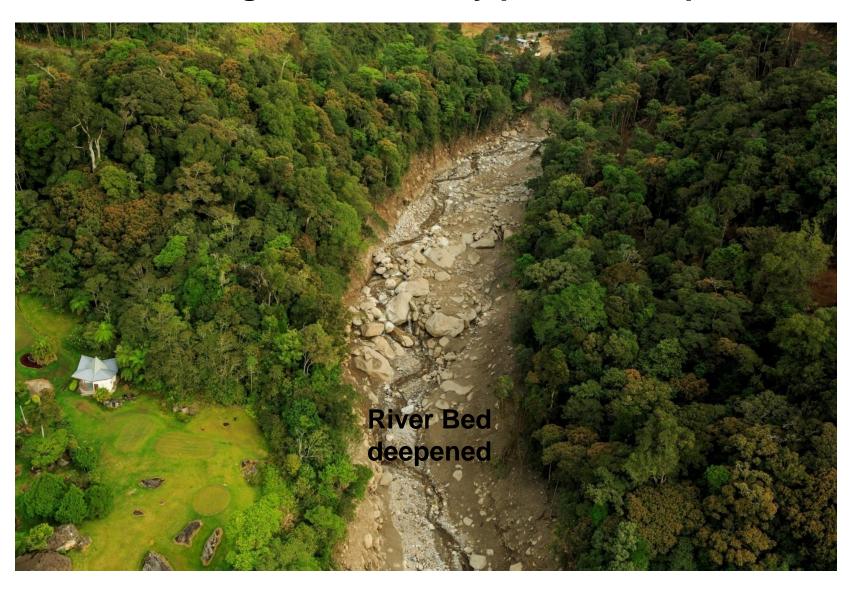
Drastic change in river valley profile - Deepened

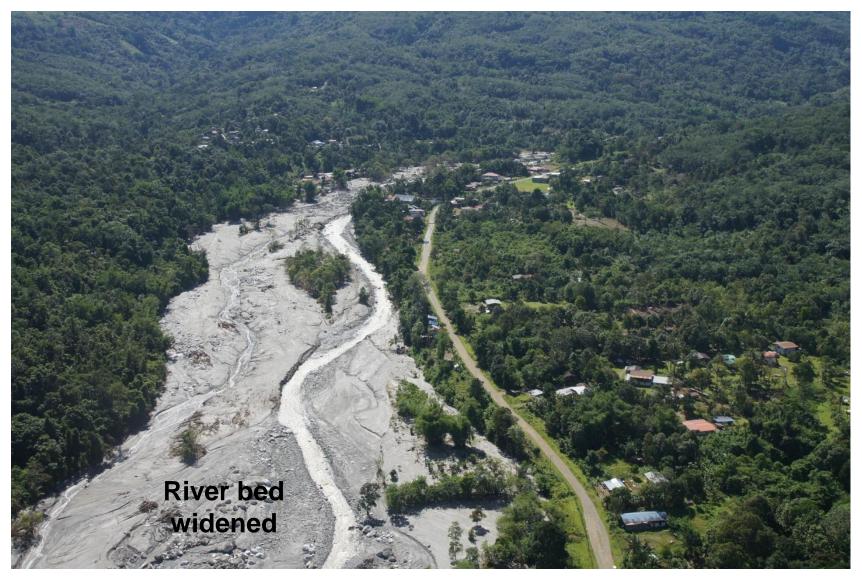
Drastic change in river valley profile – Widened

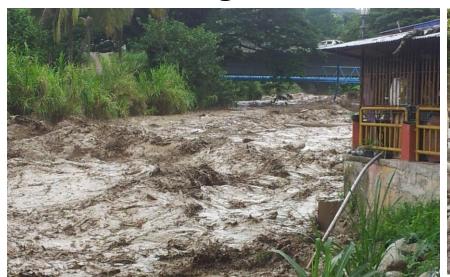
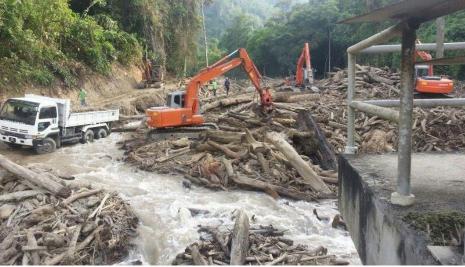
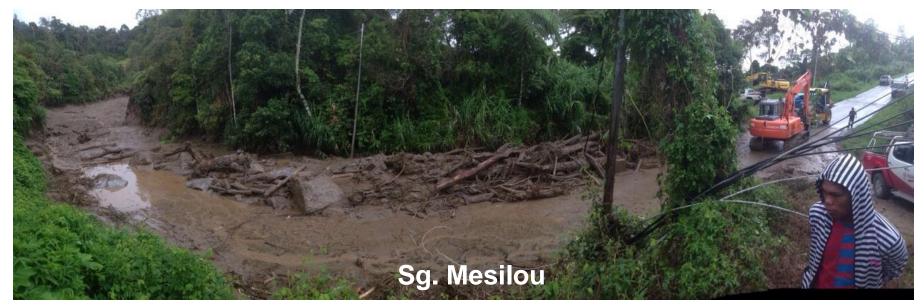
Drastic change in flow water regime – Recurrent mud flow

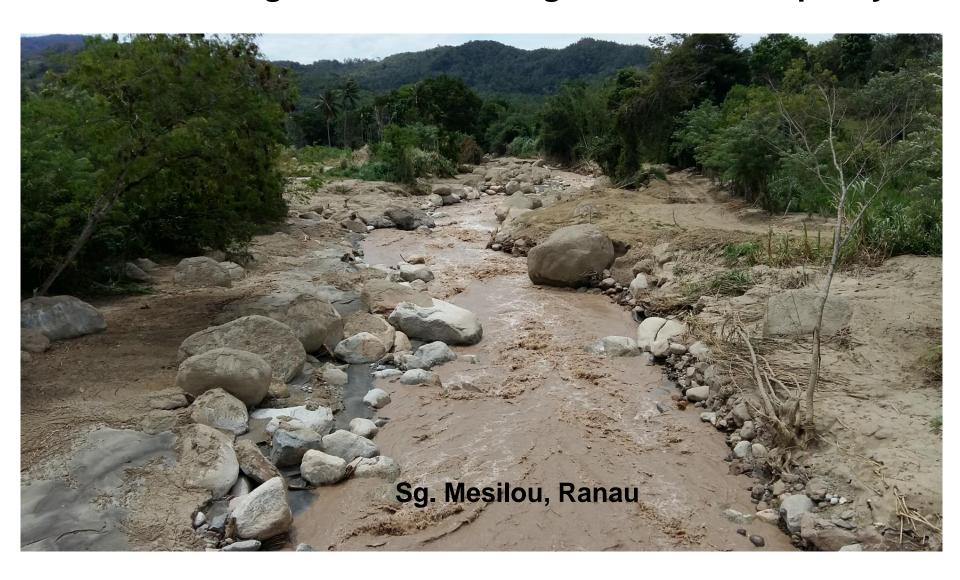
Drastic change in flow water regime – reduced quality

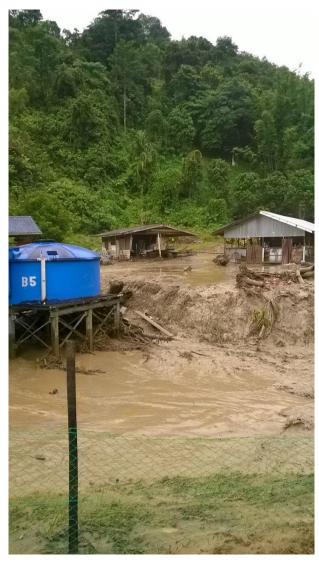
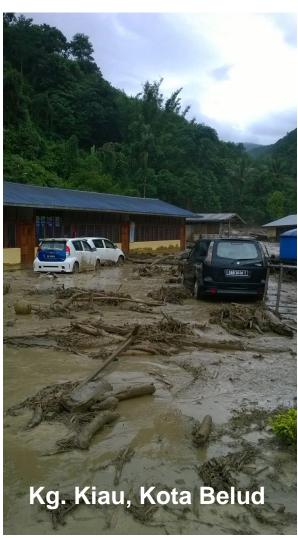
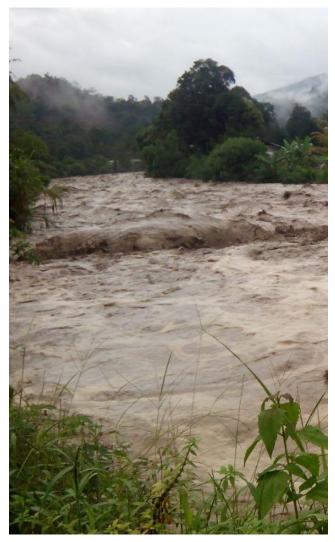
Mud flow caused destruction of buildings

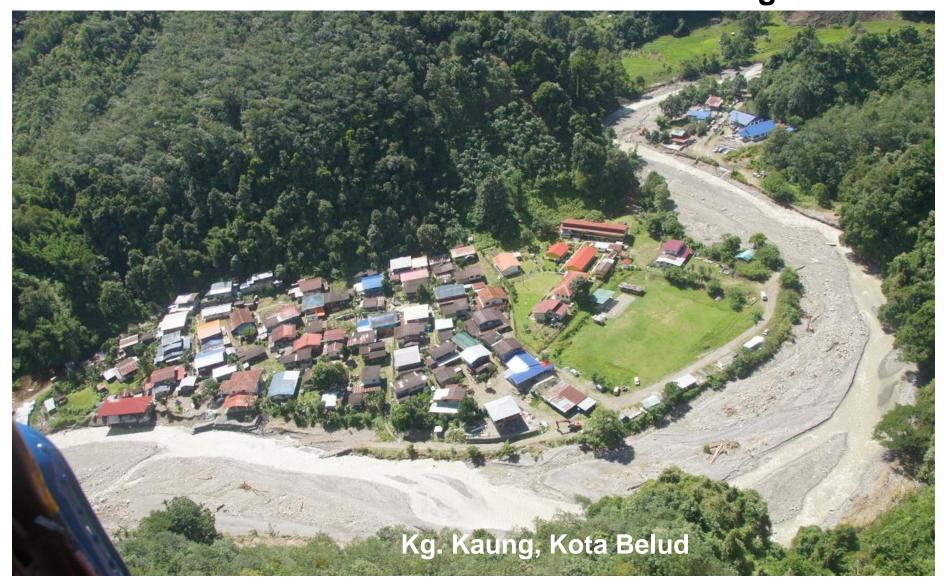
Mud flow caused destruction of buildings

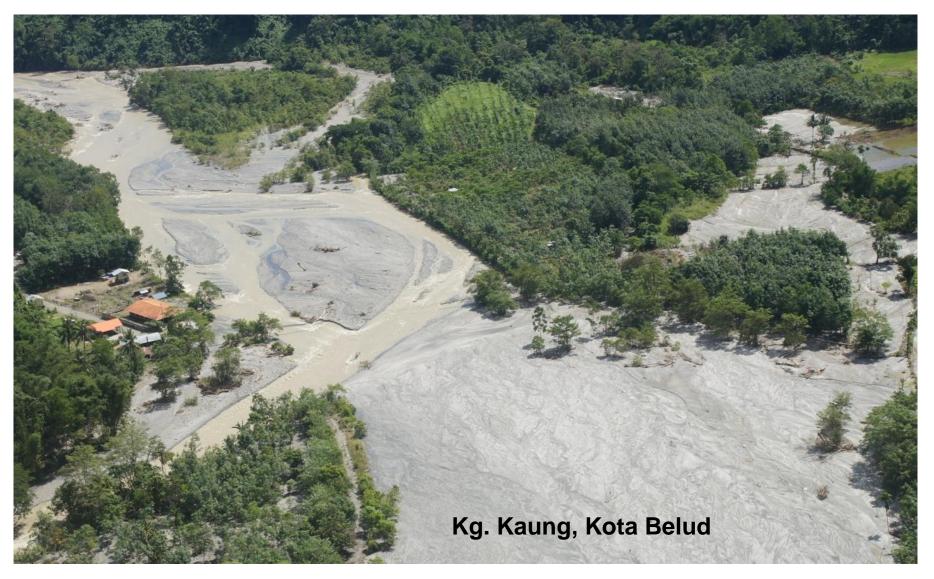
Mud flow caused destruction of farm land

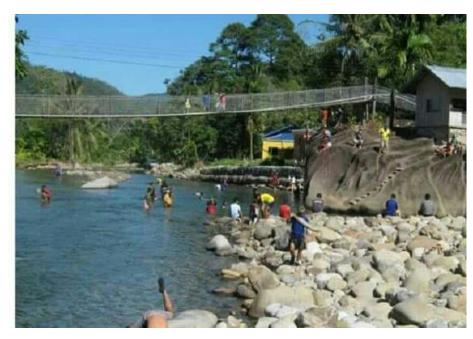
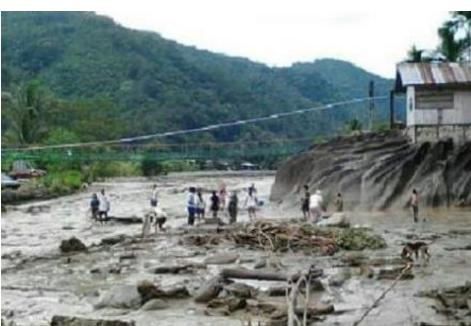
Mud flow caused destruction of ecotourism sites Before Earthquake After Earthquake

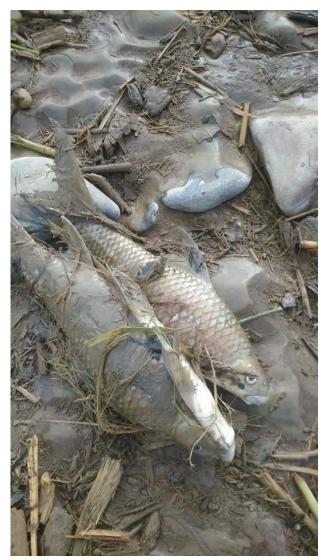
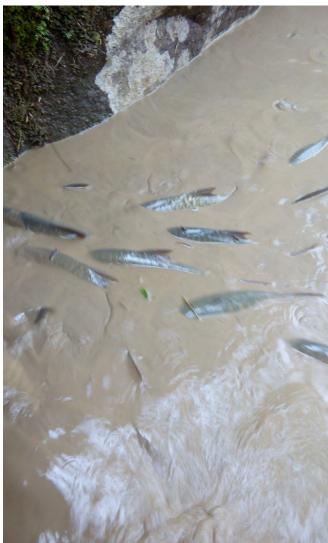
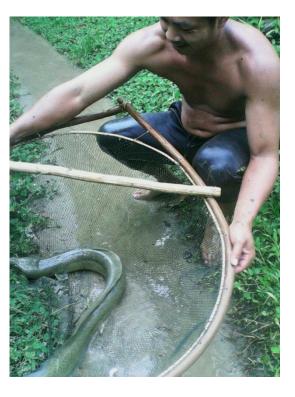
Mud flow destroyed fish resource
